**Docket No. 217 – Development and Management Plan Inspection**

Northeast Utilities Service Company Certificate of Environmental Compatibility and Public Need for the construction of a 345-kV electric transmission line and reconstruction of an existing 115-kV electric transmission line between Connecticut Light and Power Company's Plumtree Substation in Bethel, through the towns of Redding, Weston, and Wilton, and to the Norwalk Substation in Norwalk, Connecticut.

**Date:** May 06, 2004

**Location:** Norwalk Substation Expansion

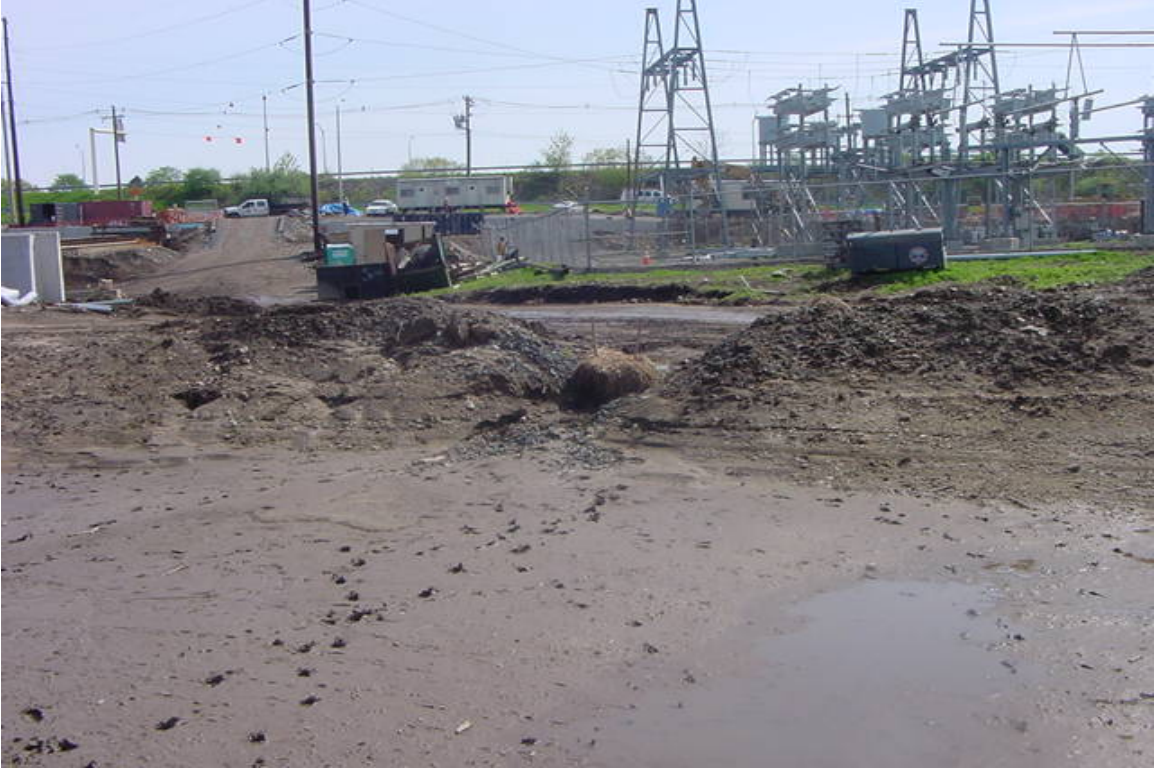
- The temporary sediment basin has only small puddles of standing water with no flow from the outlet. 5/6/04  - Some minor erosion remained along the banks of the basin but nothing structurally degrading. 4/21-5/6/04	- The piece of filter fabric at the outlet should remain in place for future storms and be cleared of sediment when it gets too full. 5/6/04  - If erosion on the slopes of the basin worsens, it should be repaired. 5/6/04

THE SEDIMENT BASIN HAS DRIED OUT. SOME EROSION AND SEDIMENT ACCUMULATION WAS NOTED NEAR THE INLET. 5/06/04

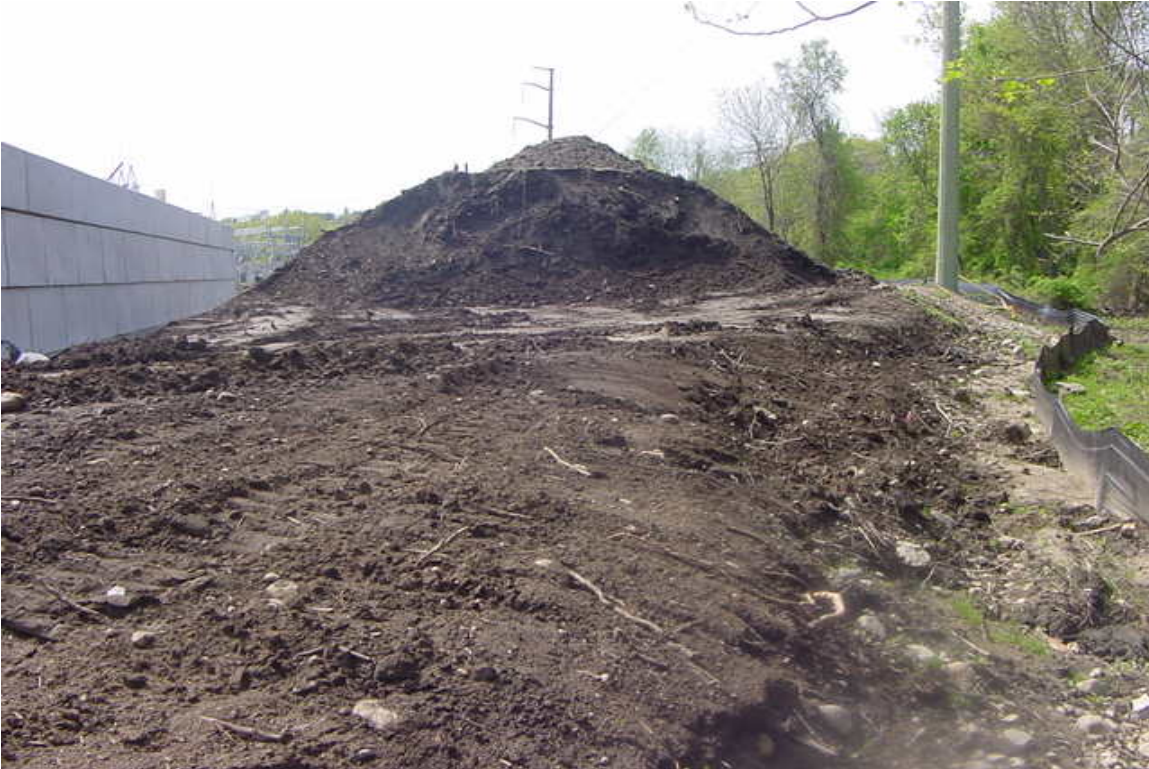
- Portions of the northerly portion of the stockpile have been used on site. The area was flattened for access and some soil was removed. 5/6/04	- The pile appears fairly stable but should continue to be monitored. 5/6/04

VIEWS OF STOCKPILE. SOIL IS BEING REMOVED FROM THE NORTHERLY END OF THE PILE AND USED ON SITE. IT HAS BEEN PLACED IN SOME OF THE SCOURED AREAS. 5/06/04

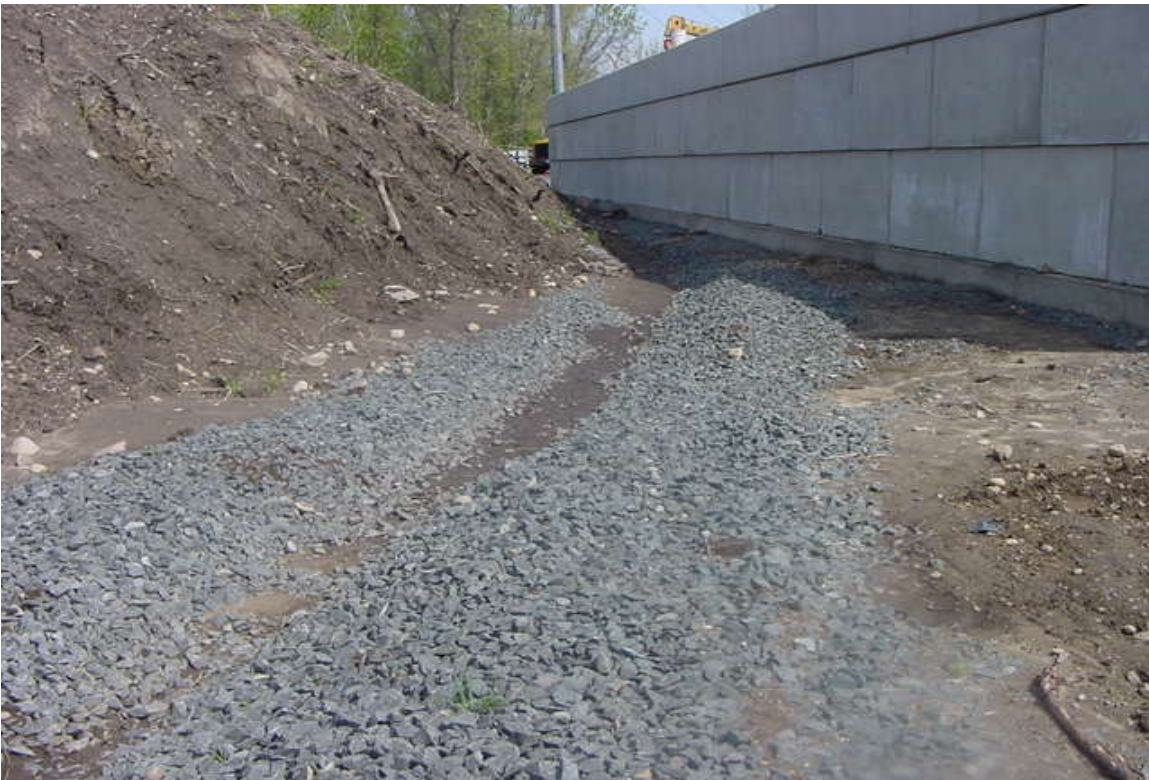
SOME SILT HAS MIGRATED INTO THE SWALE FROM THE STOCKPILE BUT REMAINS FAIRLY FIXED IN PLACE. 5/06/04

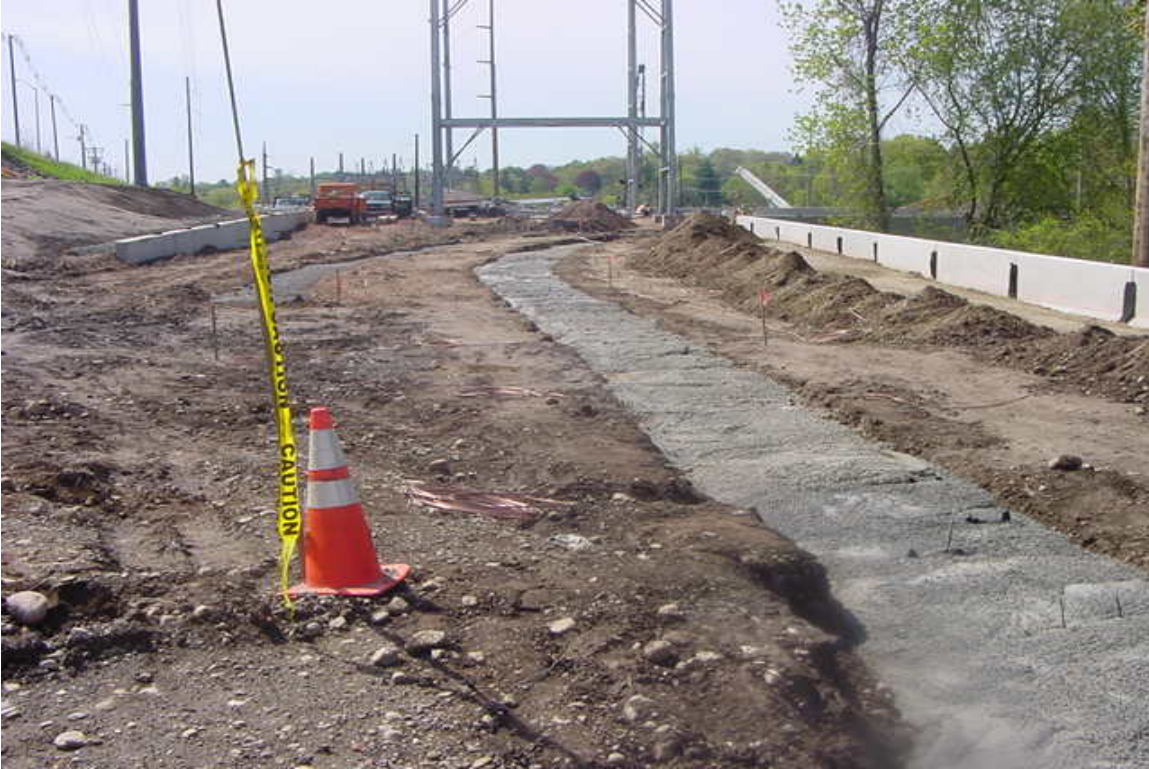
VIEW OF CONDUIT BANKS COVERED IN CONCRETE. EXCAVATIONS WERE JUST BEGINNING AT THE LAST INSPECTION. 5/06/04

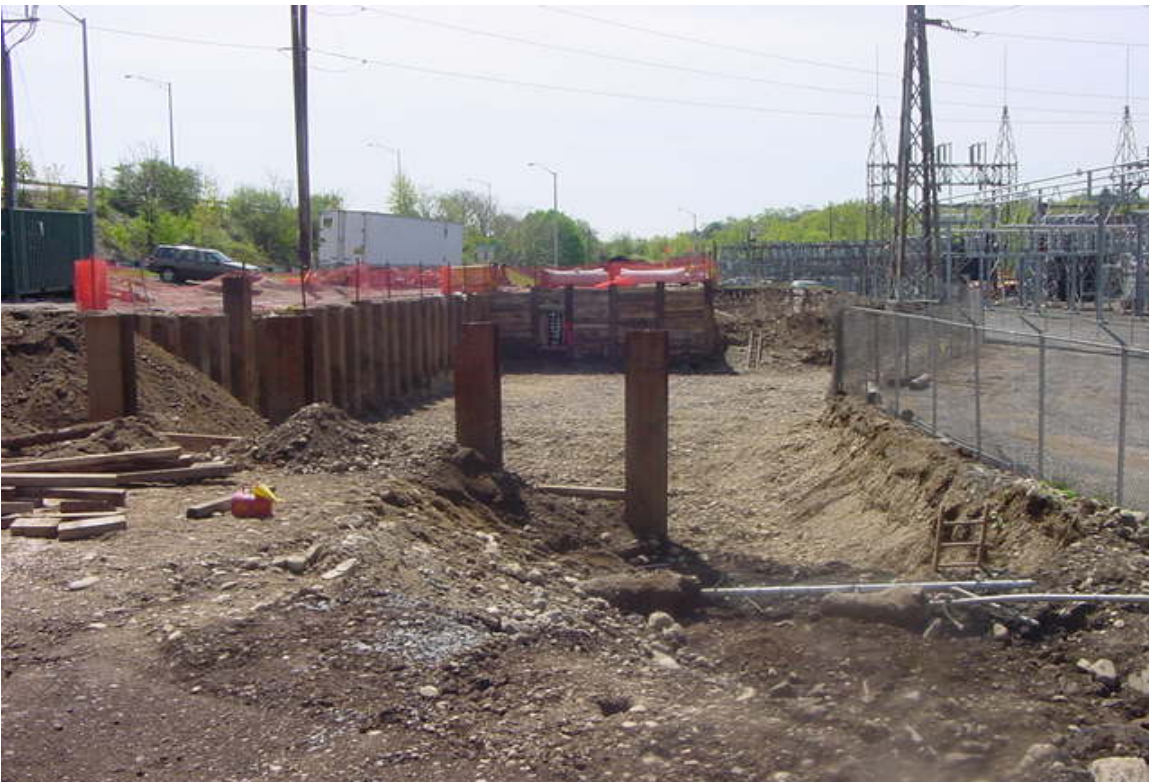
VIEW OF THE EXCAVATION FOR A SMALL CONTROL BUILDING. EXCAVATION IS CONTROLLED AND WELL DISTANCED FROM RESOURCE AREAS. 5/06/04

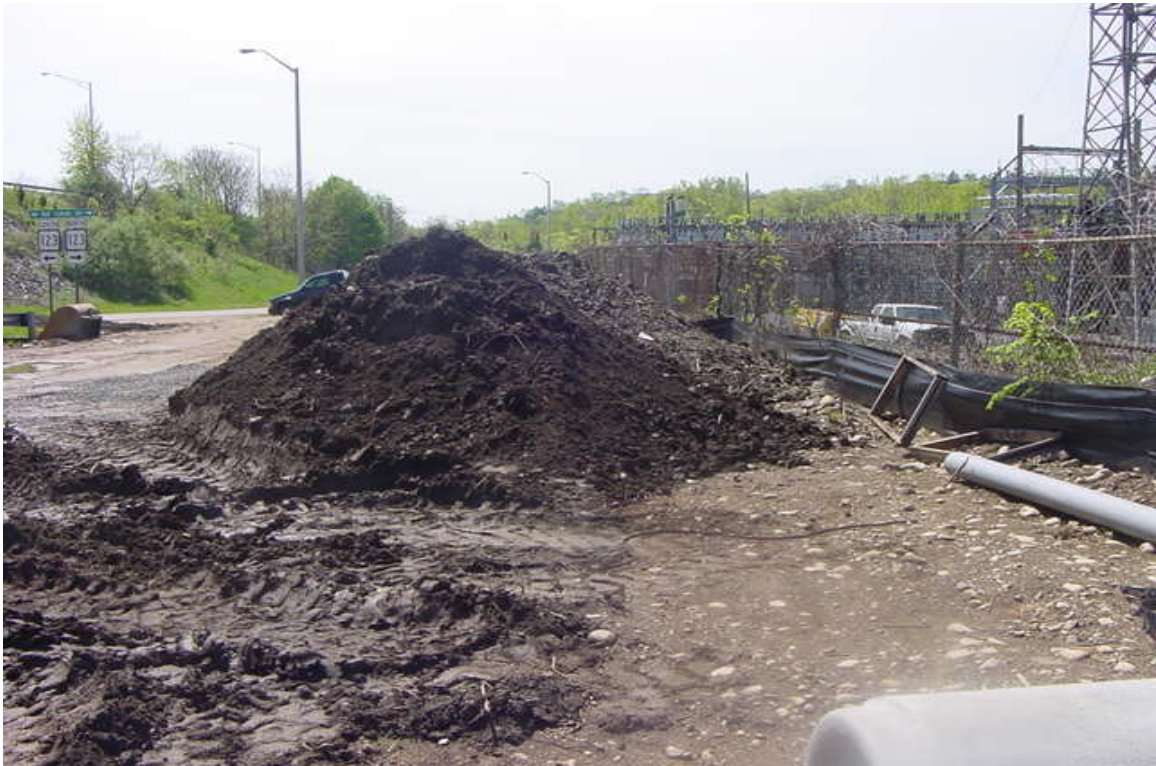
VIEW OF SOIL STOCKPILE FROM THE CONTROL BUILDING EXCAVATION, CONTAINED WITH SILT FENCE AND WELL WITHIN THE SITE. 5/06/04

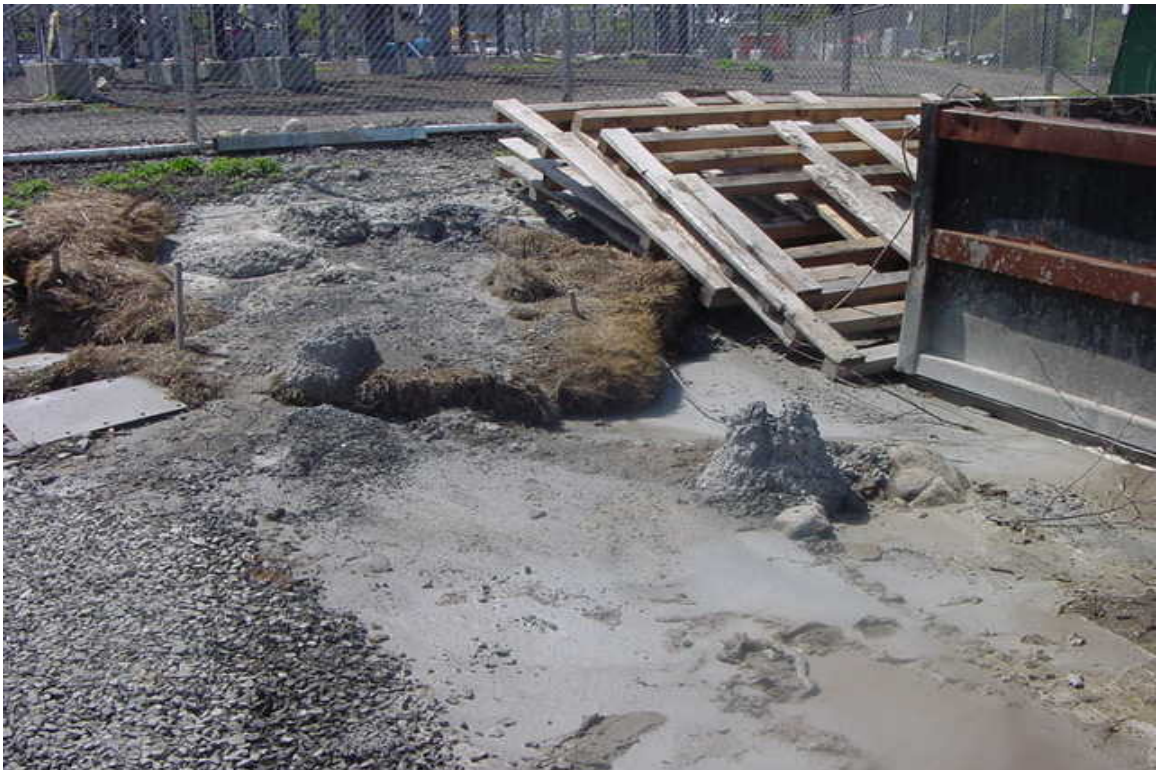
- The concrete washout station area has been used effectively by the contractors, however it may require expansion and additional controls due to overflow. 5/6/04	- The washout remains controlled on site but the station could use some maintenance. 5/6/04

VIEW OF CONCRETE WASHOUT AREA. ALL WASHOUTS HAVE BEEN DESIGNATED TO THIS ONE AREA AND IT IS BEING USED EFFECTIVELY, HOWEVER, THE CONTROLS REQUIRE MAINTENANCE 5/06/04
